Manhole Inspection Summary

Manhole # S21E1_014MH

Location Address: **2630 ridgely-huron alley**

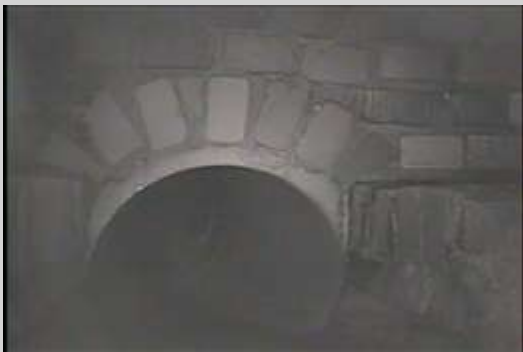
12 O'Clock Outflow

Pipe Height: **15.6** (in.) Rod and Bar (Angled)
Pipe Material: **Clay** ☐ Pipe Lined
Invert Depth: **14.10** (ft.) Flow Characteristics: **Fast**
Deposits: ☒ None ☐ Mud ☐ Sludge ☐ Debris ☐ Grease
Silt Depth: **0** (in.) Deposits Extent:
Infiltration: **None** Pipe Seal Cond: **Sound**

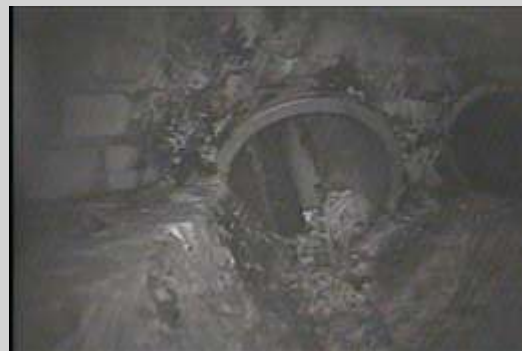
Drop In @ 3 O'Clock

Drop: **Outside** Rod and Bar
Angled: **Yes** Reading: **11.90** (ft.)
Inv Depth: **12.90** (ft.)
Drop Condition: **Open**

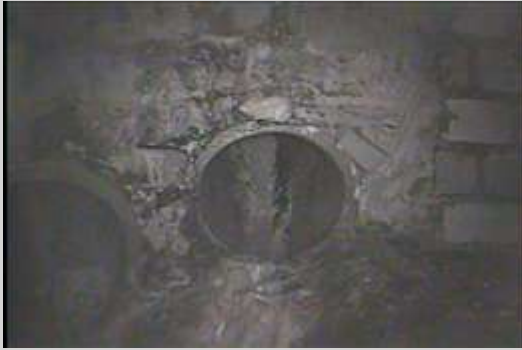
4 O'Clock Inflow

Pipe Height: **6** (in.) Rod and Bar (Angled)

Infiltration: **None**

Pipe Seal Cond: **Sound**

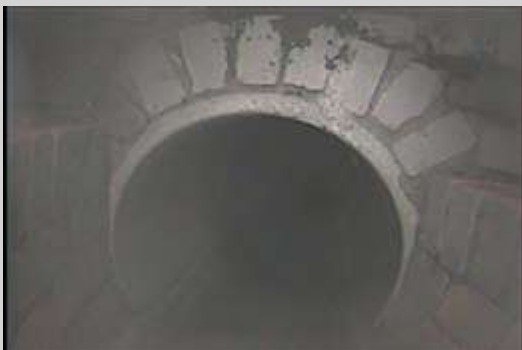
9 O'Clock Inflow

Pipe Height: **15.6** (in.) Rod and Bar (Angled)

Infiltration: **None**
